Causes Of Defects On External Wall Finishing Materials Of Buildings In Tropical Forest Area: A Case Study Of Selected Towns In Ogun State

A. A. Aiyegbajeje

Department of Architectural Technology, Federal Polytechnic Ilaro, Ogun State, Nigeria

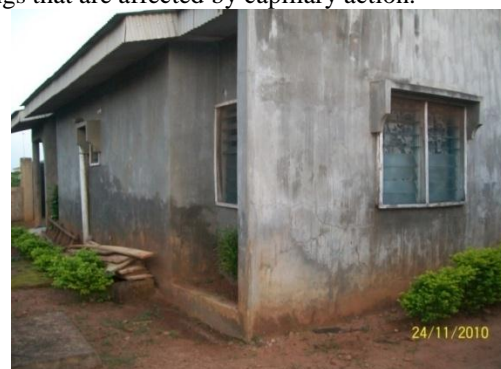
Plate 1

Capillary action occur on building that are not properly constructed in waterlog areas, the foundation walls are raised directly from the footings through the soil to the roof without the provision of damp prove elements. Periodic rainfalls soak the wall from the foundation to the superstructure thereby weakening the exterior wall finishing and reduce the service life of the finishing materials. Plates 1 and 2 are examples of buildings that are affected by capillary action.

Residential Building affected by capillary action in Ilaro
Residential Building affected by capillary action in Abeokuta

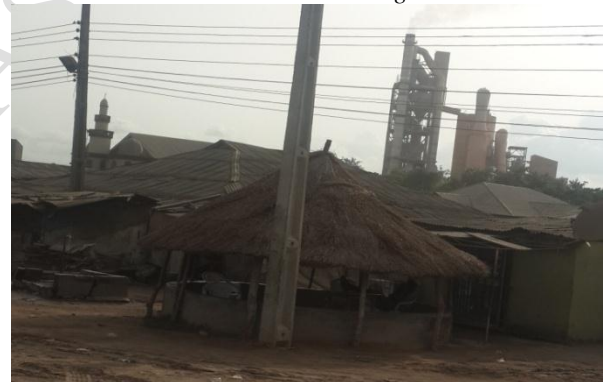
Plate 11: A residential building covered with cement dust at Itori
