Effects of Weather on Service Lives of External Building Finishing: A Case Study of Ilaro, Nigeria

A. A. Aiyegbaje

Lecturer, Department of Architectural Technology, Federal Polytechnic Ilaro, Nigeria

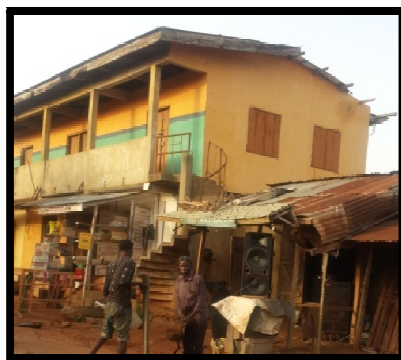
*Figure 3: Commercial Building at Orita
Oja Odan Road Completed for Over
20 Years fairly affected by Weather
Source: Authors Field Photograph 2017*

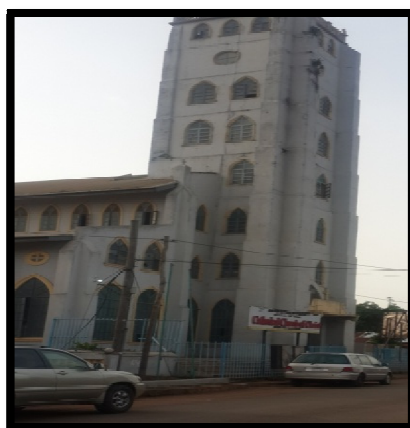
*Figure 4: Cathedral Church Ona Ola Road
Completed for Over 50 Years
Enjoys Regular Maintenance
Source: Authors Field*

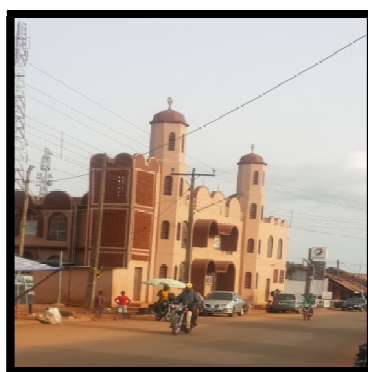
*Figure 5: Central Mosque Completed
between 20-30years fairly affected by weather
Source: Authors Field Photograph (2017)*

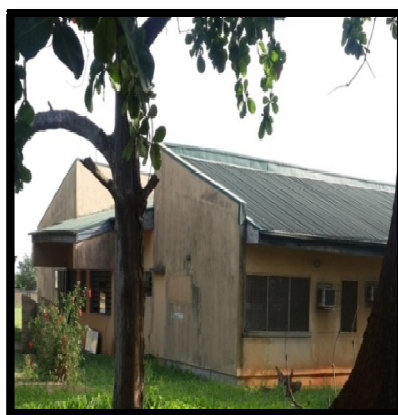
*Figure 6: Laboratory Building Rehabilitated within
The Last 10 Years at Federal Polytechnic Ilaro
Badly Affected by Weather
Source: Authors Field Photograph 2017*

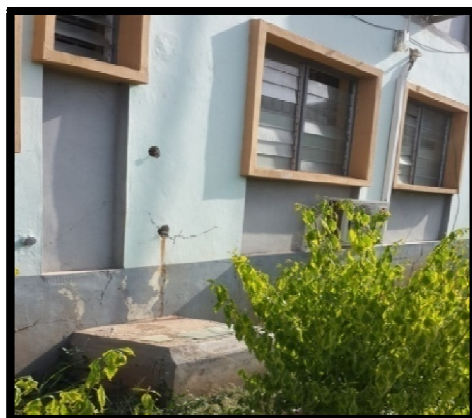
*Figure 7: Administrative Building Completed within
The Last 10 Years at Federal Polytechnic Ilaro
Fairly Affected by Weather
Source: Authors Field Photograph 2017*

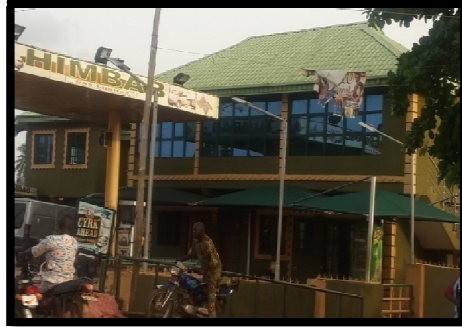
Figure 8: Commercial Building with Glass/Painted/Wall Finish along Library Area Rehabilitated within The Last 10 Years

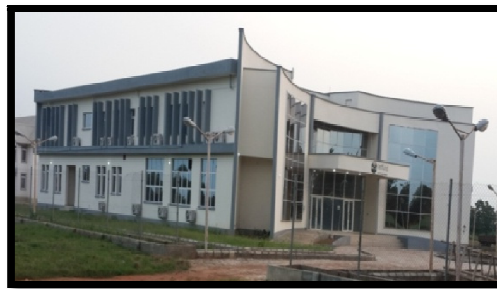
*Figure 9: International Conference Centre of Finished with Glass Painted Wall at Federal Polytechnic Ilaro, Completed within the Last 10 Years
Source: Authors Field Photograph 2017*

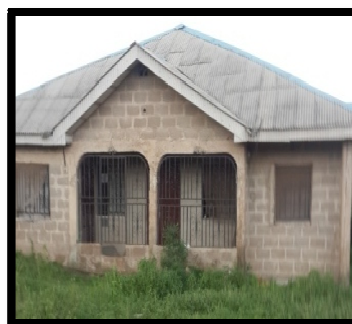
Figure 10: Residential Building with Unplastered Block Wall in Use for Less Than 10 Years at Express Road

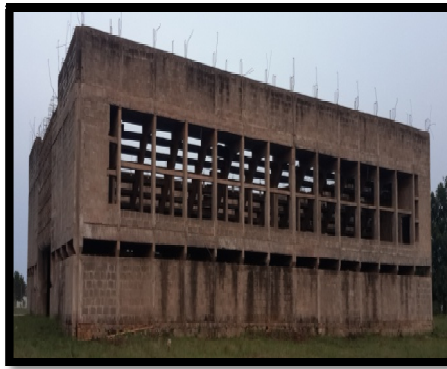
*Figure 11: Sport Centre Unplastered Block Wall Abandoned For Over 40 Years at Federal Polytechnic Ilaro. Badly Affected by Weather
Source: Authors Field Photograph 2017*

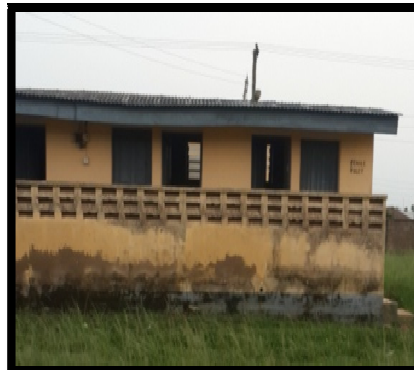
*Figure 12: Public Toilet at Federal Polytechnic Ilaro Completed in Less Than 10 Years, Badly Affected by Weather
Source: Authors Field Photograph 2017*

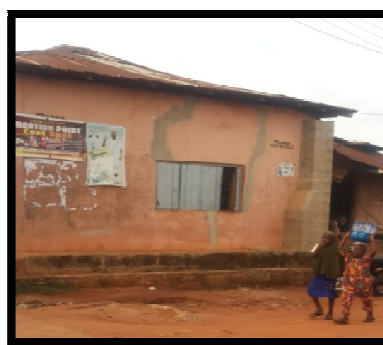
*Figure 13: Classroom Building at Library Area Completed in Less Than 10 Years, Badly Affected by Weather
Source: Authors Field Photograph 2017*
