**EFFECT OF WEATHER ON SERVICE LIVES OF
EXTERNAL BUILDING FINISHINGS: A Case Study of Ilaro.**

Aiyegbajeje A. A. and Adejugbagbe J. A
Department of Architectural Technology Federal Polytechnic Ilaro, Ogun State

25th to 27th July, 2017

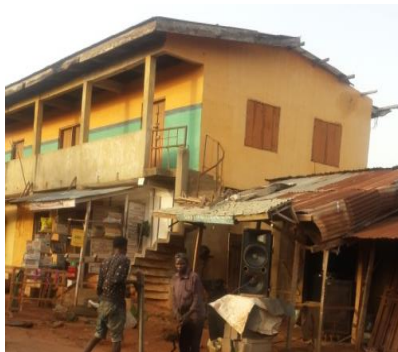
Plate 2 Commercial building at Orita Oja Odan road Completed for over 20 years fairly affected by weather
Source: Authors field photograph 2017.

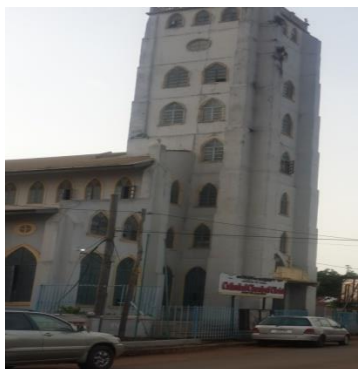
Plate 3 Cathedral church Ona Ola road completed for over 50 years Enjoys regular maintenance.
Source: Authors field photograph (2017).

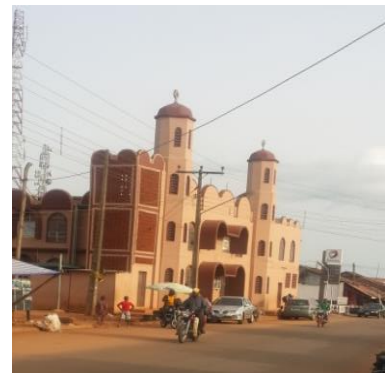
Plate 4 Central Mosque ilaro completed between 20-30 years fairly affected by weather
Source: Authors field photograph (2017).

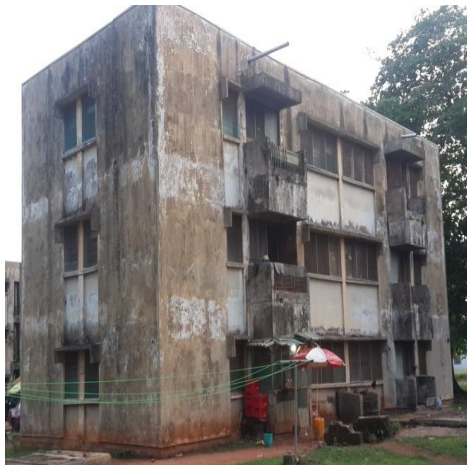
Plate 5, Residential building not maintained within 30 – 40 years at Federal Polytechnic Ilaro badly affected by weather.
Source: Authors field photograph (2017).

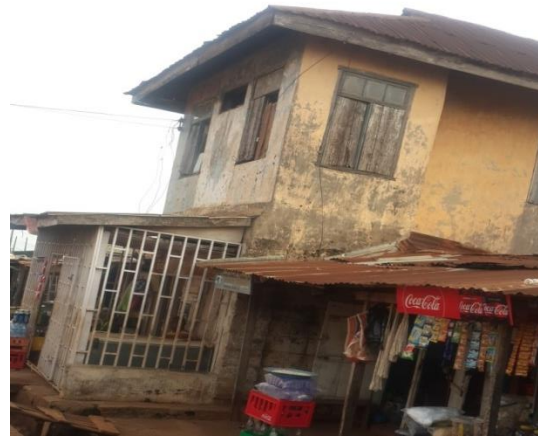
Plate 6 Mixed residential/commercial not maintained for over 50 years at Ona Ola road badly affected by weather
Source: Authors field photograph (2017).

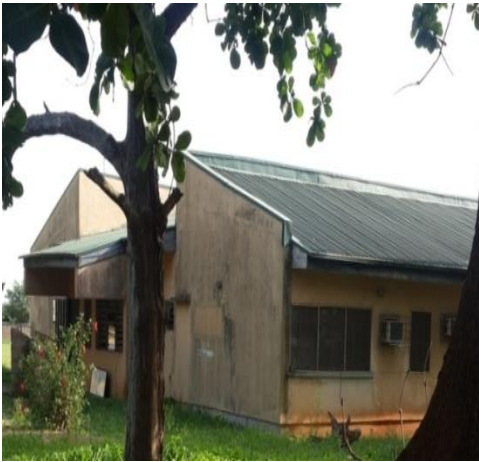
Plate 7, Laboratory building rehabilitated within the last 10 years at Federal Polytechnic Ilaro badly affected by weather.

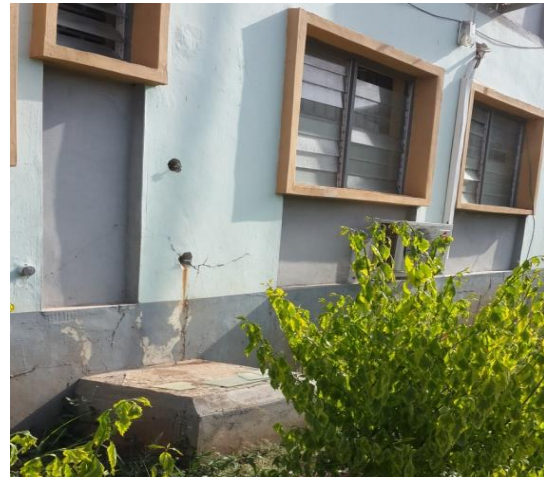
Plate 8, Administrative building completed within the last 10 years at Federal Polytechnic Ilaro fairly affected by weather

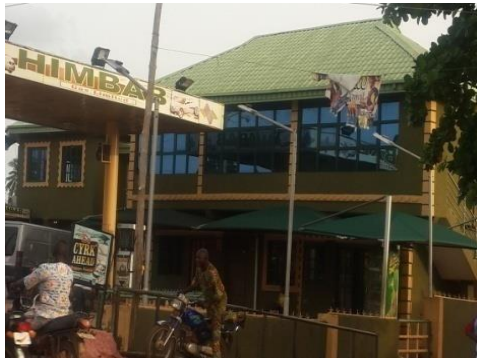
Plate 9 : Commercial building with glass/painted along Library area rehabilitated within the last 10 years.

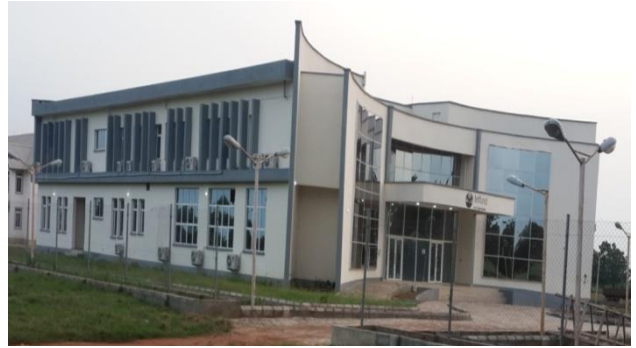
Plate 10 International Conference Centre of finished with glass / wall finish at Federal Polytechnic Ilaro. Completed within the last 10 years

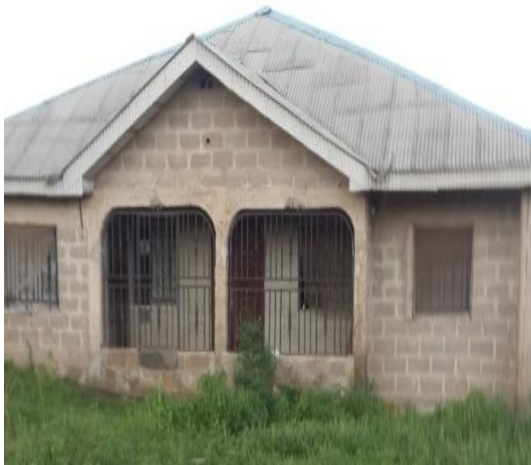
Plate 11 Residential building with Unplastered block wall in use for less than 10 years at Express road.

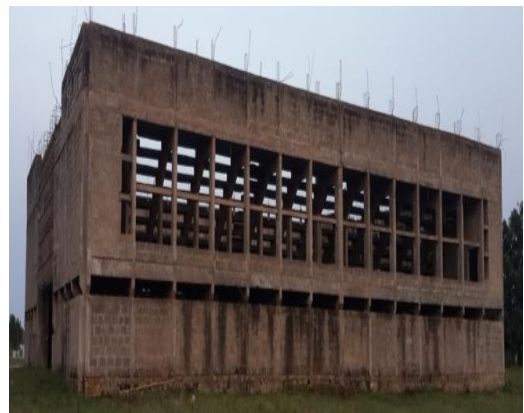
Plate 12 Sport centre Unplastered block wall abandoned for over 40 years at Federal Polytechnic Ilaro. Badly affected by weather.

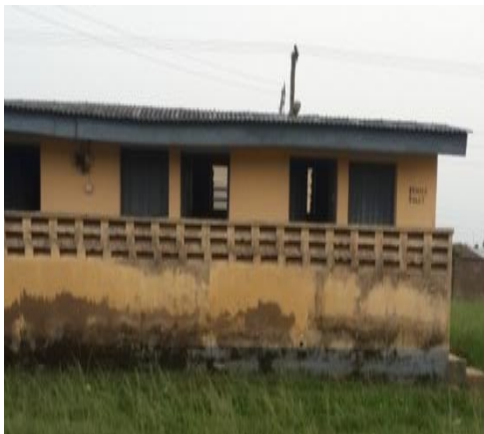
Plate 13 . Public toilet at Federal Polytechnic Ilaro Completed in less than 10 years. Badly affected by weather
Source: Authors field photograph 2017.

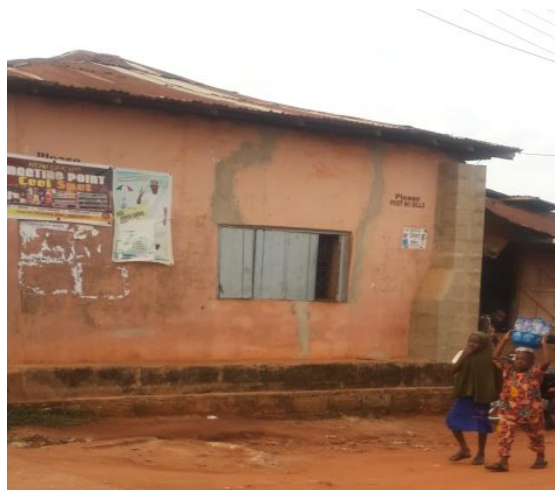
Plate 14, Classroom building at Library area completed Completed in less than 10 years. Badly affected by weather
Source: Authors field photograph 2017.
