**ASSESSING THE EFFECTS OF BAD ROADS ON TRAVEL PATTERN: CASE STUDY
OF ATAN –LUSADA ROAD, ADO-ODO OTA LOCAL GOVERNMENT AREA,
OGUN STATE.**

SODIYA, OLUROTIMI OLUYEMI (email: tplsodiya@gmail.com)

5th National Conference of the School of Environmental Studies,

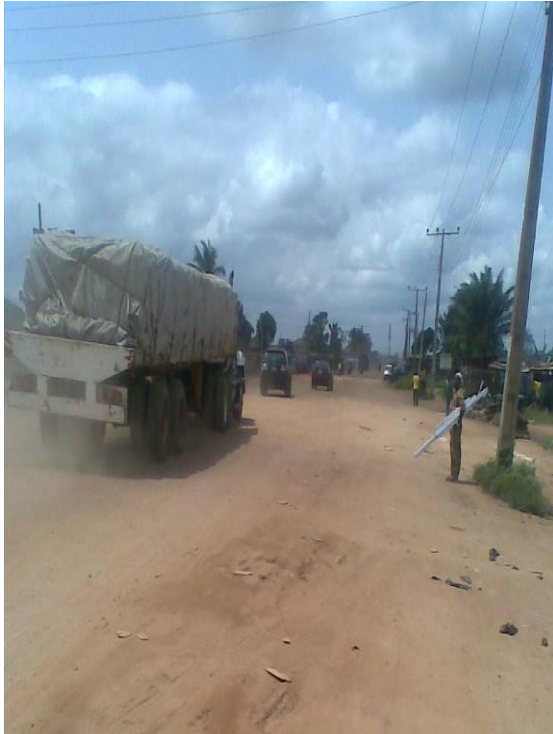
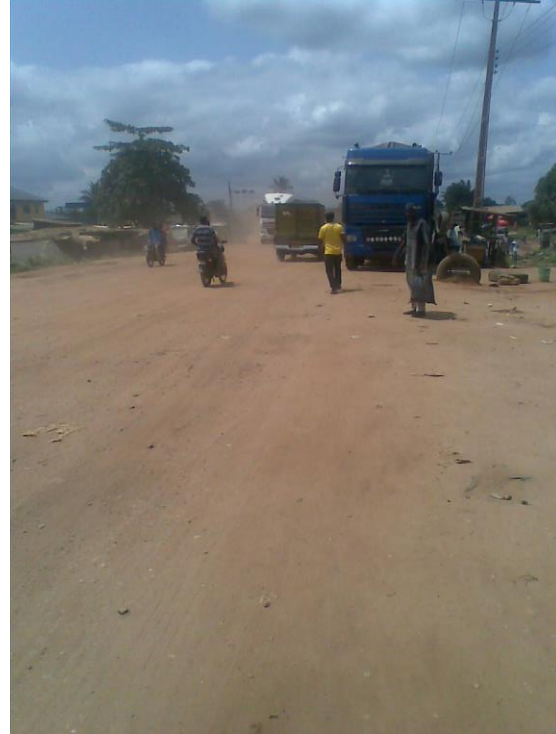
Plate 2: The Condition of the Road

The road is under construction due to its bad condition. The bad condition of the road is manifested in an unpaved surface, unstable surface due to flooding and erosion, and lack of drainage which makes runoff difficult.

The road understudied is characterized by unpaved surface with different dimensions of potholes which resulted into increase in travel time. The problem is aggravated during the raining season due to the occurrence of flooding and erosion. The high volume of rain water during the raining season resulted into either slow movement of vehicles or non-passage of vehicles, while the eroded debris forms barriers to the easy flow of vehicles. Traffic problems of this corridor is unique due to the nature of the road and its land use composition. Due to the bad condition of road, competition for spaces for the movement of various categories of vehicles occurred. Often time, the small available spaces for movement are competed for between commercial motor cycle and the heavy duty vehicles, while observation revealed that the frequency of private cars plying the corridor is significantly low. It is noteworthy to point out that , broken down vehicles along the road occupied available spaces for the movement of vehicles, and also served as collision points for moving vehicles, particularly at night, and during poor visibility, which may be caused by weather or any other factor. However, the ongoing construction work is at a slow pace, and this further make the surface of the road to remains unstable.
